June 28, 2019
File No. 262018.063

Subject: Department of Natural Resources Washington Geological Survey,
School Seismic Safety Assessment Project, Contract No. AE 410 -
Seismic Evaluation for **Fife School District**

School Buildings Evaluated in the Fife School District

1.1 Building Description

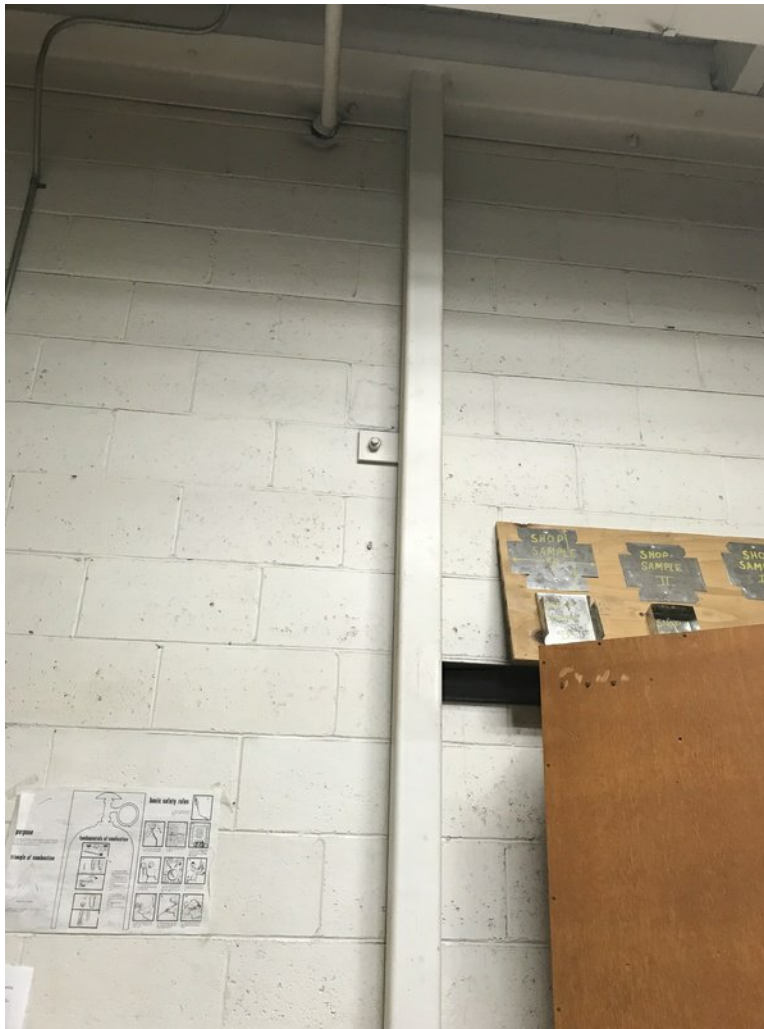
Figure 1-6. CMU wall steel strongback.
